Broadway and Cruse Parking Garage

Preliminary Engineering Report

Prepared For:
Dept of Administration
1310 East Lockey
Helena MT 59620

Prepared By:
Stahly Engineering & Associates, Inc.
3530 Centennial Drive
Helena, MT 59601
(406) 442-8594

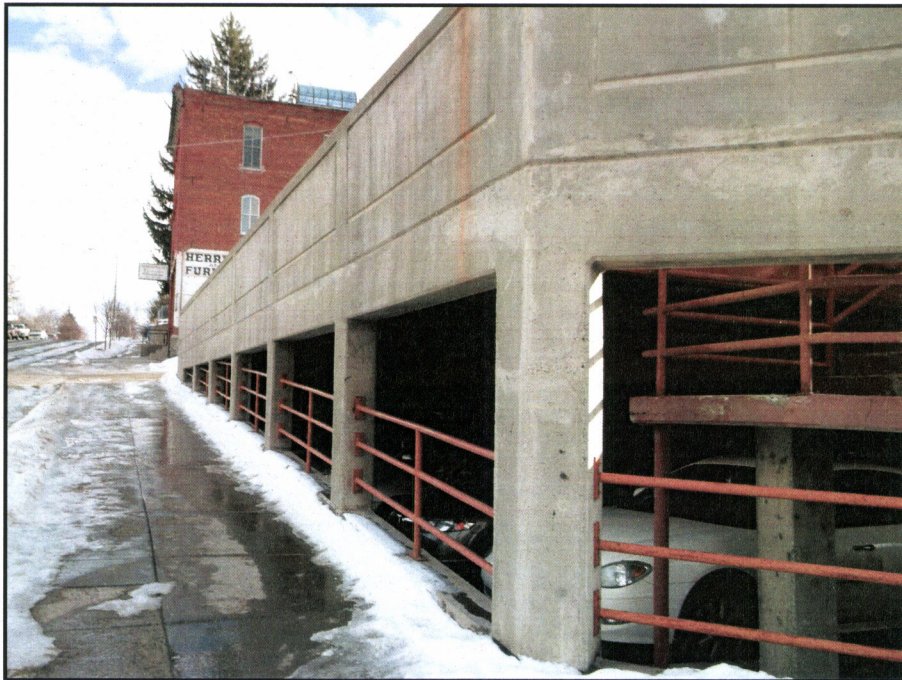
Figure 1 - Broadway & Cruse Parking Garage

The parking garage located at the SE corner of the Broadway and Cruse intersection in downtown Helena has noticeable signs of deterioration. The purpose of this preliminary engineering report is to analyze different options available to remedy the current situation. In order to get an idea of the structure's current condition, field measurements were taken and initial beam calculations were performed. The data collected along with observations made during site visits provided the basis for the recommendations and alternatives that are provided.
